Lucrările Seminarului Geografic Dimitrie Cantemir

Vol. 42, October 2016, pp. 39-48

Land degradation processes in the catchment of Stemnic river (Buda)

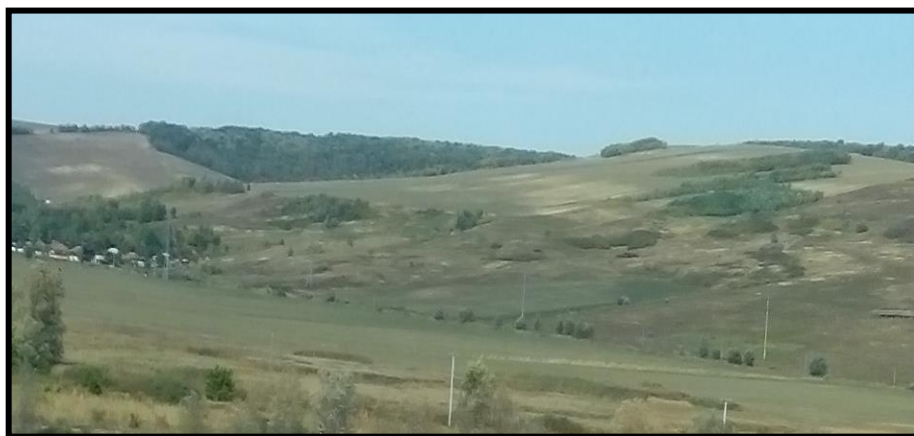
Figure 4 Erosion in the surface at East of Răduiești locality (5th October 2015)

In the middle catchment it grows obviously the poderosity of the agricultural surfaces and of the anthropic pressure upon the land, to which it is added a series of morphometric particularities (increased declivities, high relief energy, relatively intense fragmentation) (fig. 4).

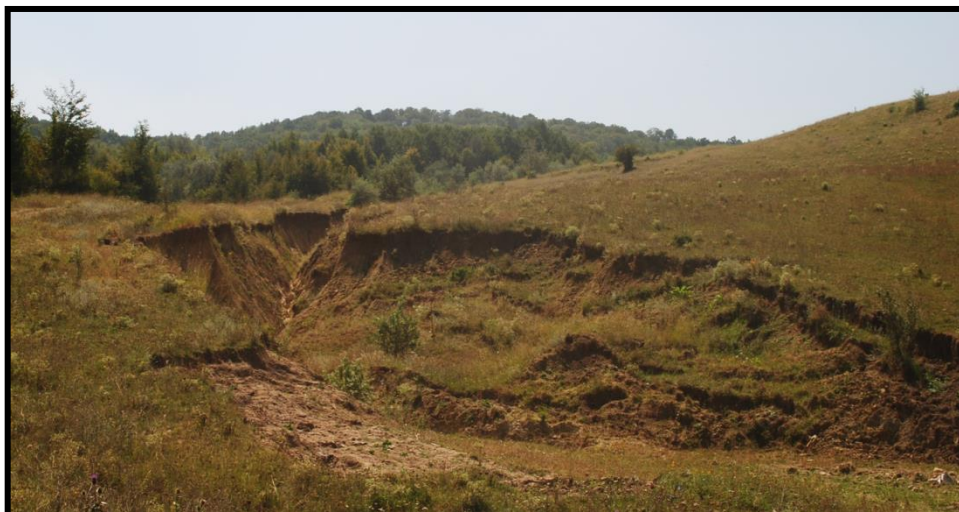
Large size gaps develop on the cuesta fronts, like those on cuesta of Buda, cuesta of Bălești (fig 5). The versant gaps occupy 37 ha and are generally discontinuous and have reduced dimensions and depths, while valley bottom gaps have larger dimensions and a continuous character, but occupy a much reduced surface, of 25 ha.

Figure 5 Versant gap (8th August 2013)

The depth of the gaps varies between 1 and 5 m and can reach greater depths (of over 10 m). The communication ways (roads) may be affected by the appearance and development of the gaps, along with taking off the agricultural circuit of those surfaces (62 ha).

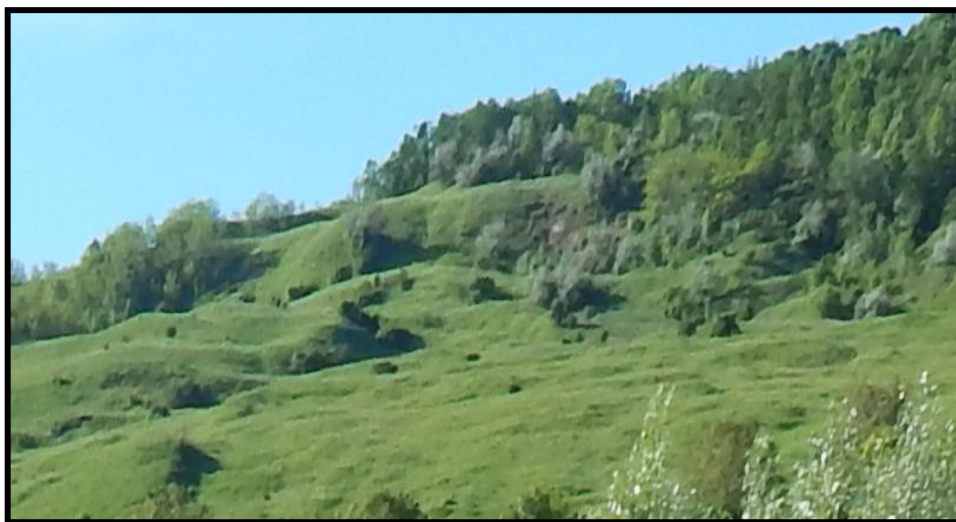
We can see landslides on the right versant of the Fâstâca river, near Bălești locality, on the right versant of Stemnic, downstream Buda locality or near Răduiești locality (fig. 7).

Figure 7 Landslides in steps in the upper catchment basin of Stemnic (Buda) (17th May 2014)

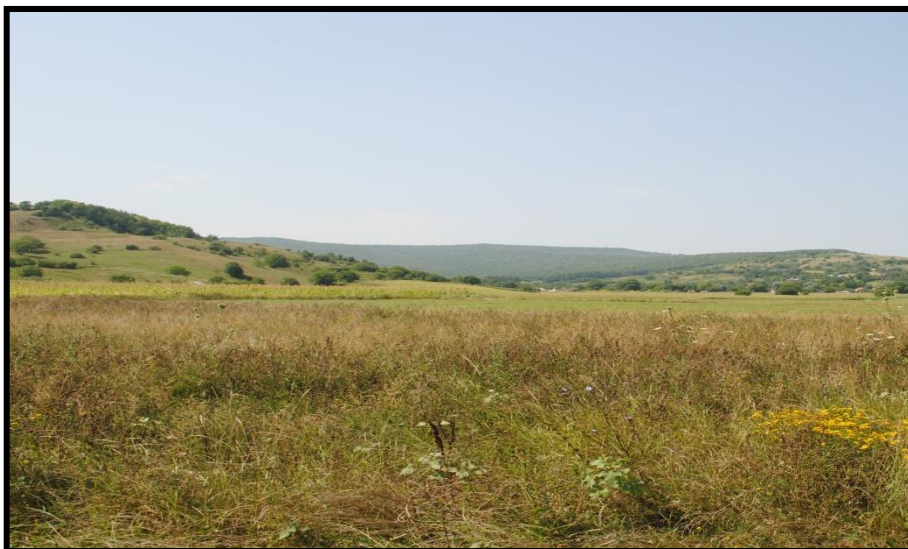
Aggradation of the alluvial plains represents the geomorphologic process of elevating by alluviation of the flooded meadows (figure no. 8). The floods produced as a result of snow melting, the torrential rains or some long term rains are responsible for the deposit of the materials on the alluvial plains, sometimes being accumulated large quantities of material, with effect in burying the preexisting soils.

Figure 8 Aggradation of the plain of Stemnic (Buda) (10th August 2013)

The observations made in the field lead us to the conclusion that the value of the aggradation rhythm of the meadows in the catchment of the Stemnic (Buda) is medium, a fact confirmed also by the relatively reduced thickness of the alluvion. This thing is possible because of the high degree of timbering (27.8%), the predominantly clayey lithology of the sub layer, the spreading of soils with clayey and loam – clayey texture (17.2%), with an increase resistance to erosion, deposit of a significant part of the eroded material at the junction of the versants with the alluvial plains.
